# Manhole Inspection Summary

Manhole # S21MM\_027MH

Insp Date: **6/29/07 11:26 AM**

**Location** Address: **2238 FULTON AVE**

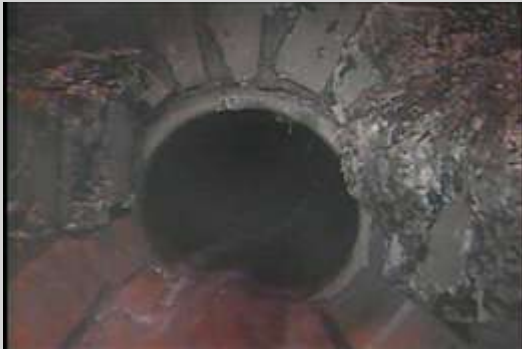
12 O'Clock Outflow

8 in. Circular Gravity Sewer  
Pipe Out @ 12 O'Clock

Pipe Height: **8.4** (in.) Rod and Bar (Angled)  
Pipe Material: **Clay** ☐ Pipe Lined  
Invert Depth: **9.72** (ft.) Flow Characteristics: **Slow**  
Deposits: ☒ None ☐ Mud ☐ Sludge ☐ Debris ☐ Grease  
Silt Depth: (in.) Deposits Extent:  
Infiltration: **None** Pipe Seal Cond: **Sound**

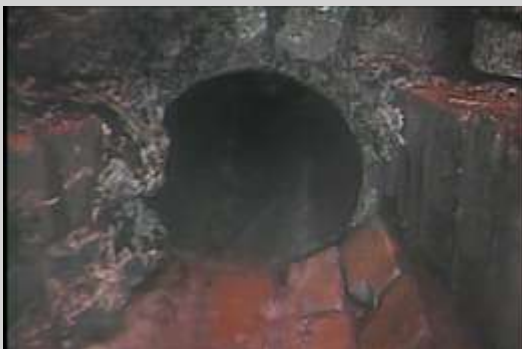
3 O'Clock Inflow

8 in. Circular Gravity Sewer  
Pipe In @ 3 O'Clock

Pipe Height: **8.4** (in.) Rod and Bar (Angled)  
Pipe Material: **Clay** ☐ Pipe Lined  
Invert Depth: **9.54** (ft.) Flow Characteristics: **Slow**  
Deposits: ☒ None ☐ Mud ☐ Sludge ☐ Debris ☐ Grease  
Silt Depth: (in.) Deposits Extent:  
Infiltration: **None** Pipe Seal Cond: **Sound**
